Considerations over the Italian road bridge infrastructure safety after the Polcevera viaduct collapse:
past errors and future perspectives

Fabio Bazzucchi, Luciana Restuccia, Giuseppe Andrea Ferro

ABSTRACT. In the last four years, Italy experienced the collapse of five road bridge: Petrulla viaduct (2014), Annone (2016) and Ancona (2017) overpasses, Fossano viaduct (2017) and Polcevera (2018) bridge.

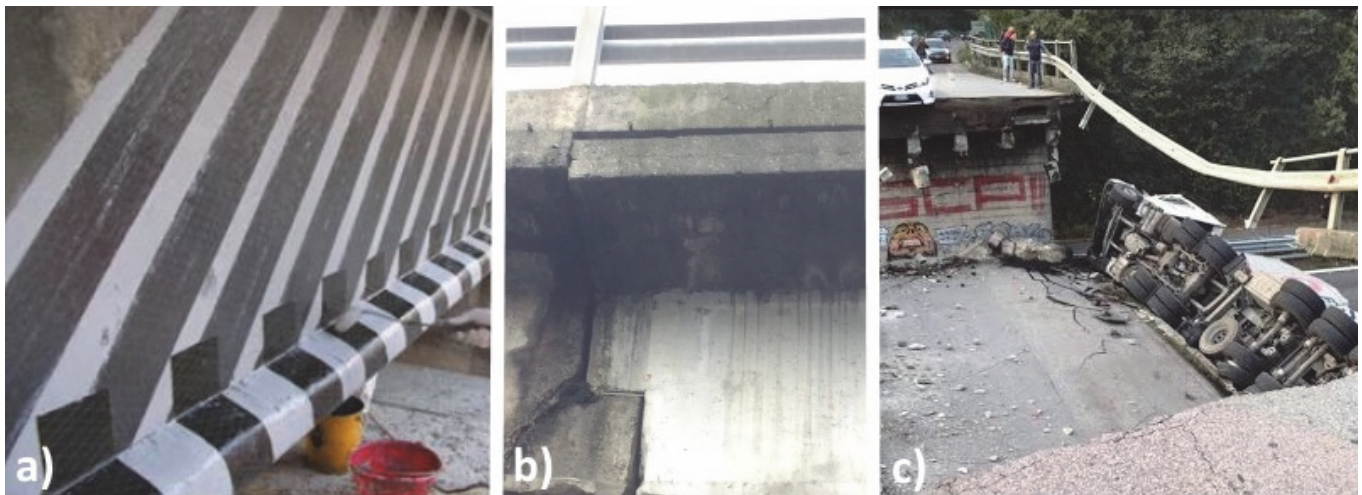
The collapse occurred when a 107.6 t heavy 8-axels truck went across the deck with a low moving speed (Fig. 5(c)). Once the load was carried entirely by the central beam, the external repaired dapped end corbel collapsed due to the vertical reaction established for supporting the beam. Total weight on the structure was approximately 172 t, which is 10 % higher than the maximum design load adopted equal to 155 t. However, this excess should have been overcome in the safety factor. This bridge was catalogued as category II by Italian Building Codes [3], but the safety requirements were not fulfilled by the structural properties. Investigation [1] have demonstrated that this failure was compromised by:

- an initial design flaws in the dapped-end corbel that significantly reduced the ultimate load;

- reinforcement in the precast beams was not enough to ensure a category II bridge classification;
- the presence of a shear fracture along the dapped end corbel promoted the oxidation of the reinforcement bars in the joint;
- the passage of II category loads (more than 100 per year) puts frequently the structure close to its ultimate bearing capacity.
- the eccentricity produced by a transit misaligned by the carriageway central line significantly increased the loading in the external dapped end joint.

Figure 5: Dapped end corbel conditions before the collapse (a); humidity presence and water stagnation (b); failure loading configuration (c) [1].

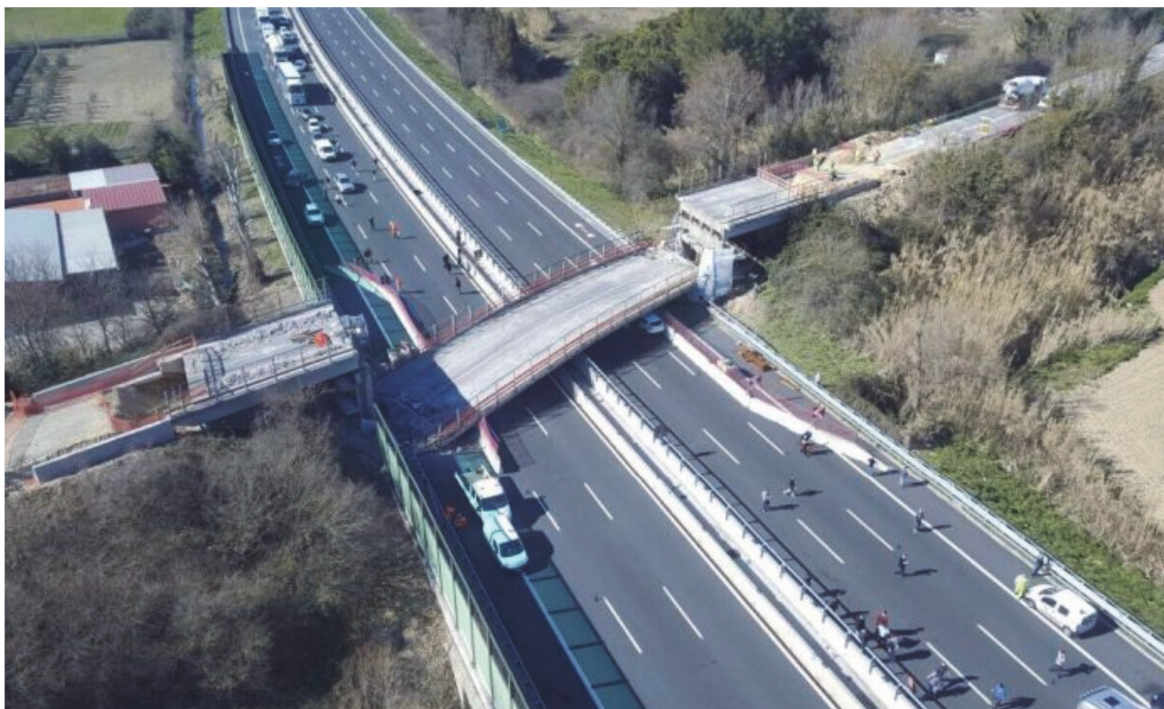
Figure 6: Ancona overpass after the collapse (from web site www.cronacheancona.it).

The case of the collapse of the overpass on the A14 motorway near Ancona is quite different from the others and was caused only by a resounding error during the execution phase. The works involved the adjustment of the altimetric height of the overpasses, consisting of raising the decks, creating an extension of the support structures and the re-profiling of the associated ramps. The lifting took place through the use of hydraulic jacks with few centimeters steps, after positioning of steel plates for distribution. The appointed subcontractor to perform this specific process decided to replace the supporting steel plates with similar plates in neoprene, much lighter to move. Numerical analyses conducted during investigations by prof. Tarantino highlighted how a difference between the temporary supports of a few millimeters generates horizontal forces not compatible with the shear deformability of the numerous neoprene plates stacked on top of each other. This generated an unexpected bridge horizontal displacement and the collapse occurred. Further details are under investigation.

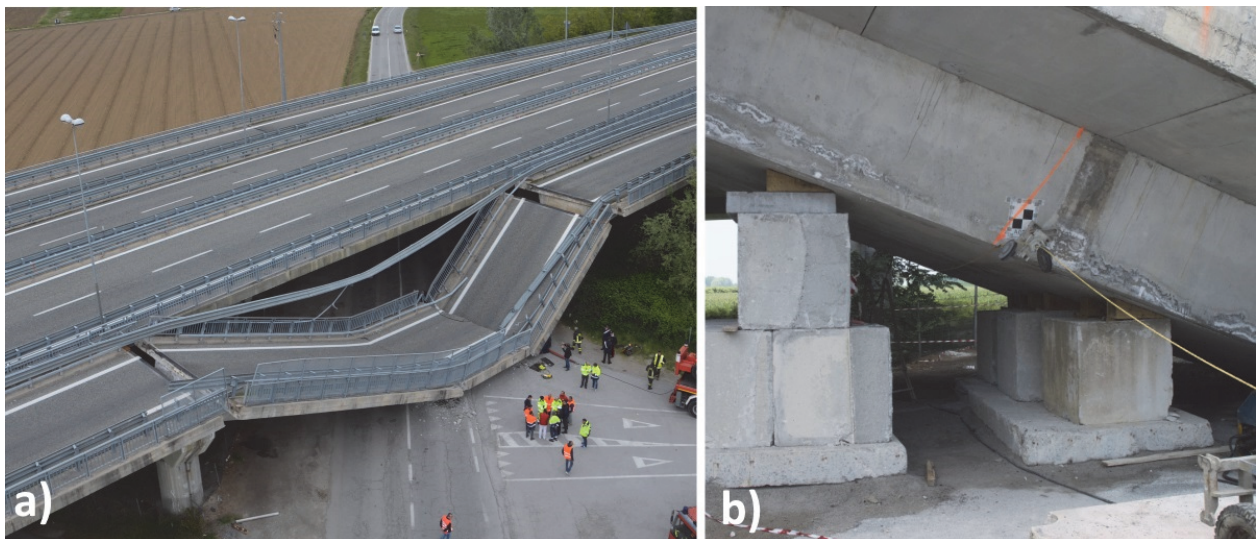
Figure 7: Overview of the collapsed Fossano bridge (a) and structural scheme (b).

The collapsed overpass is one of the 108 that constitutes the Fossano (Cuneo) bypass road. This road has several viaducts, and the one involved in the failure is one of the ramps of La Reale Viaduct, where it crosses the S.P. 165. The collapse occurred on April 18, 2017, and luckily (2.45 p.m.) no vehicles were going across or underneath the structure. The sudden collapse took place without out-of-plane displacements (Fig. 7(a)). A modest slip ahead in one of the bearings has been identified in the collapsed configuration. The structure was a simply supported beam, 30.80 m long and 8.90 m wide, constituted by a multiple-box post-tensioned beam and by a in-situ casted slab. The section was realized by connecting two concrete precast U-elements by a shear-key casted in situ. In the longitudinal direction, the bridge was built in 3 segment, the central one 11.50 m long and the lateral ones 9.35 m long. The connection between the segments was realized by an in-situ casted concrete joint 0.5 m wide (Fig. 7(b)). Post-tensioning system constituted in 8 parabolic cables, each of them made by 19 0.8" strands. Total weight of the structure was about 400 t. The collapsed structure evidenced an intact joint and a collapsed one, together with an evident shear failure where the bridge impacted the ground. For this event, several information can not be given at the moment due to secrecy related to the running investigations. Visual inspections consented to affirm that the collapse mechanism was triggered by a shear failure in one of the joint due to the absence of the equilibrating action of the prestressing (Fig. 8). This means that in some part between the support and the intact joint, the cables were damaged. Visual inspections immediately also demonstrated that the cables did not have sufficient grout protection in the collapsed joint area (Fig. 9(a)). The damage was not compatible with a 20 years old

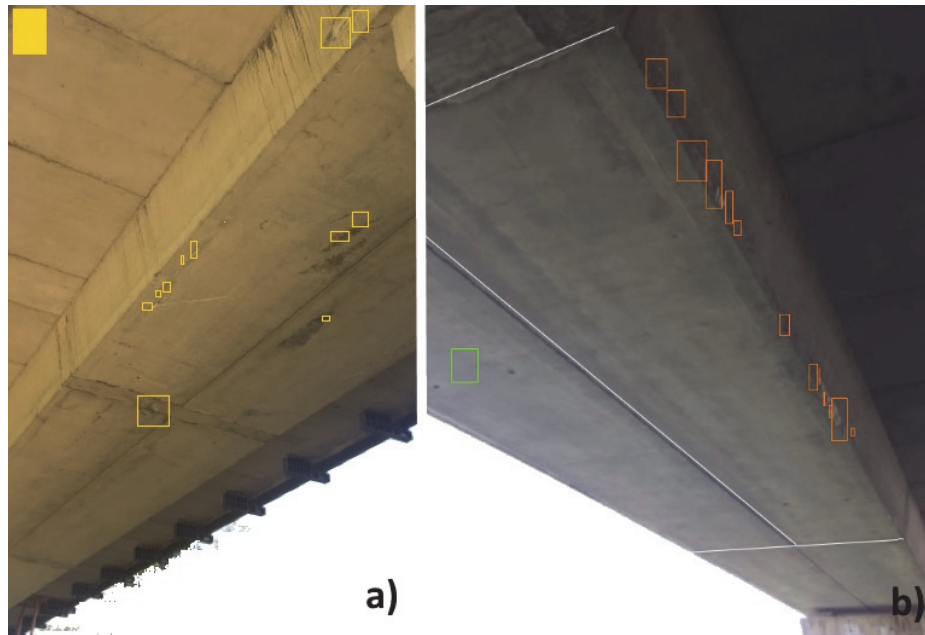
Figure 25: mismatch of damage degree (a); element-scale analysis (b).
